F-8-91

Bowers-Barton Farm

Johnsville, Maryland

# Maryland Historical Trust State Historic Sites Inventory Form

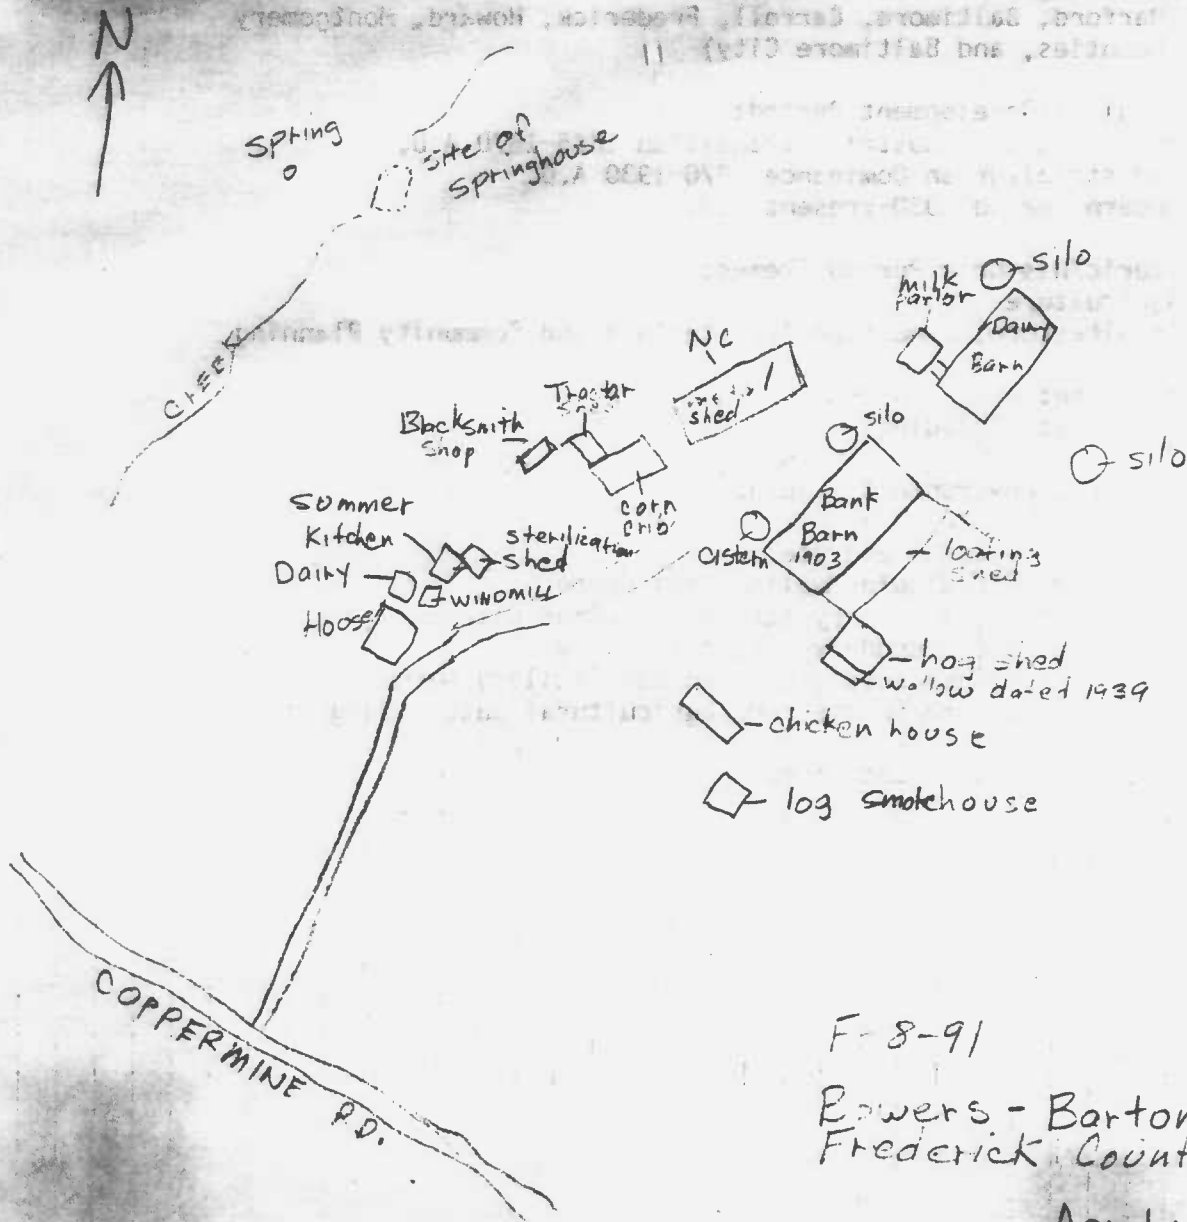
F-8-91

summer kitchen materials  
 from neighboring farm Fox  
 wagon shed near creek, originally  
 house ell 1890  
 house earlier  
 dairy barn 1951

barn: horse stalls  
 horse pens  
 2 feeding areas  
 for cows  
 slate roof under S.S. metal

April 10, 1991  
 Janet Davis  
 Not to scale

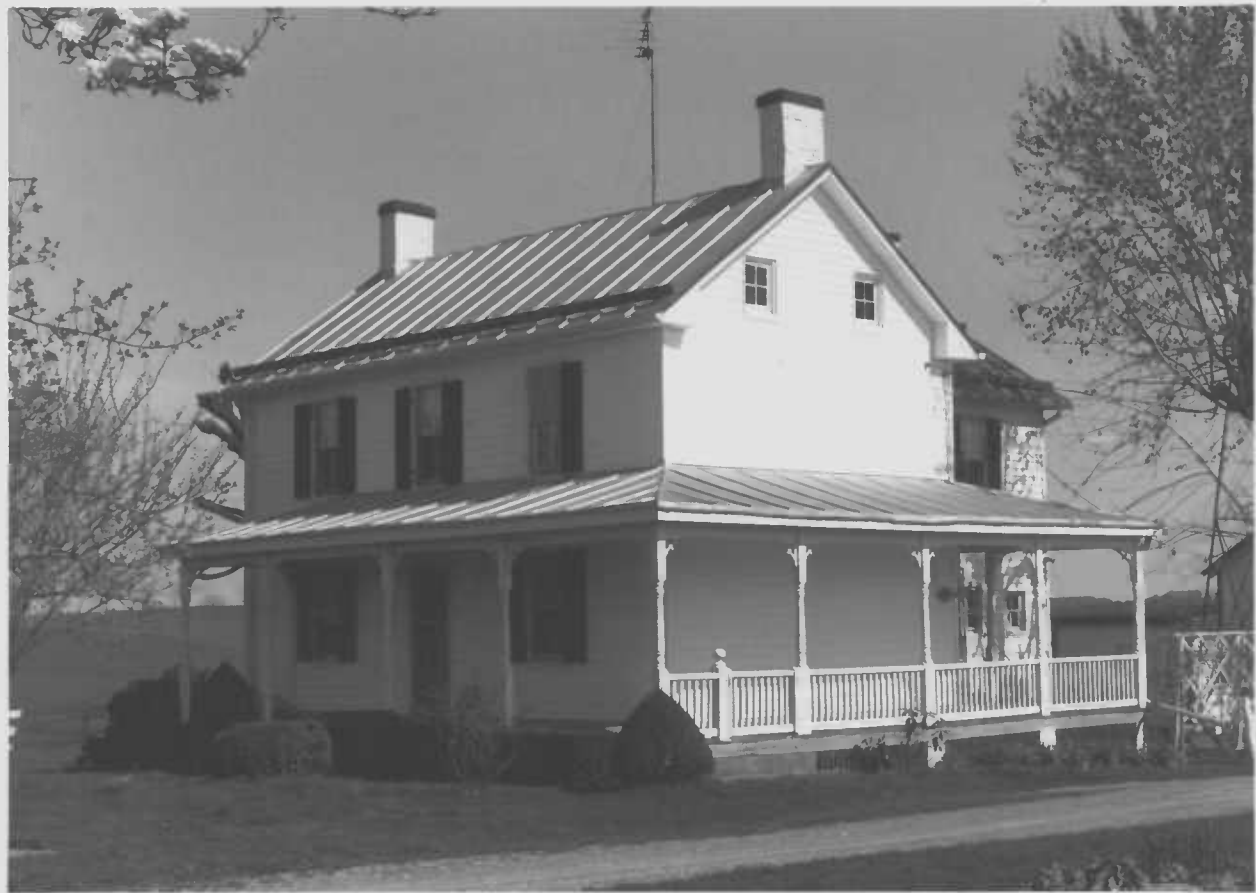
1/5

The house is a two-story, three-bay log dwelling with a center entrance and a one-story shed porch on the southwest and south elevations. A two-story frame rear ell was built in about 1890 according to the current owner. The 2/2 windows are flanked by working shutters. The gable roof is standing seam tin with interior end chimneys. The exterior covering of the house is vinyl over clapboards. The interior of the house was inaccessible for this survey.

House, southwest corner view

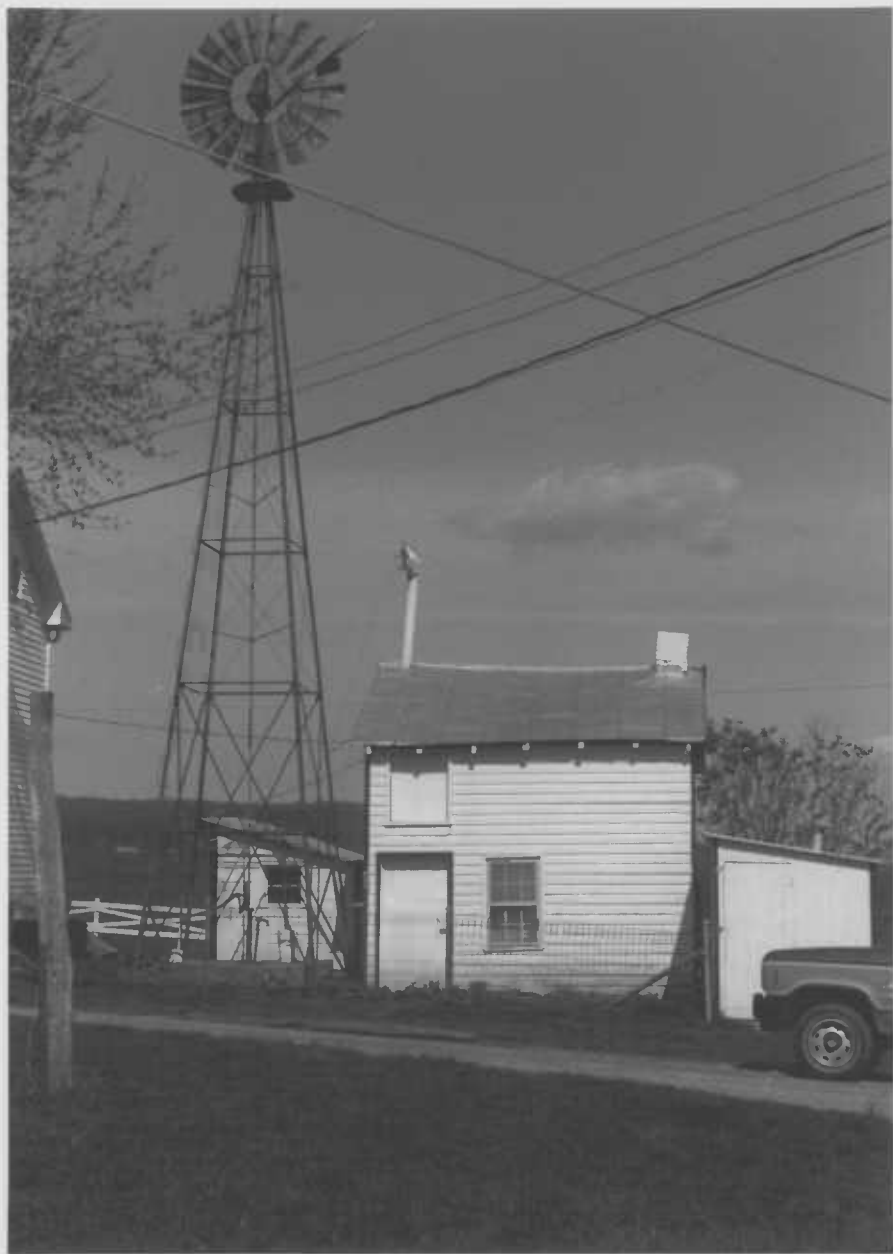
2/5

Dairy: This is a frame, shed-roofed building with german siding located immediately northeast of the ell.

Windmill: The windmill is located immediately south of the dairy over the well. It is in operating condition although not in continuous use.

Summer kitchen: This is a two-story frame building which includes a wash house within the same structure. It has a standing seam tin roof with a brick interior chimney at the east gable end. A single door and window are on the south elevation. The siding is german. The summer kitchen is northeast of the windmill/well. Materials for the summer kitchen were brought from a neighboring farm.

Milkcan Sterilization Shed: This frame shed is located at the southeast corner of the summer kitchen. Its probable date of construction is about 1890. The siding is tongue and groove.

Chicken House: A frame, shed roofed structure with its windowed side facing southwest. It is located about 50 feet southeast of the house. The siding is tongue and groove.

Log Smokehouse: Located south of the chicken house, the smokehouse has vertical flush board siding and a corrugated metal roof. It is probably contemporary with the house.

Domestic outbuildings, view from  
South

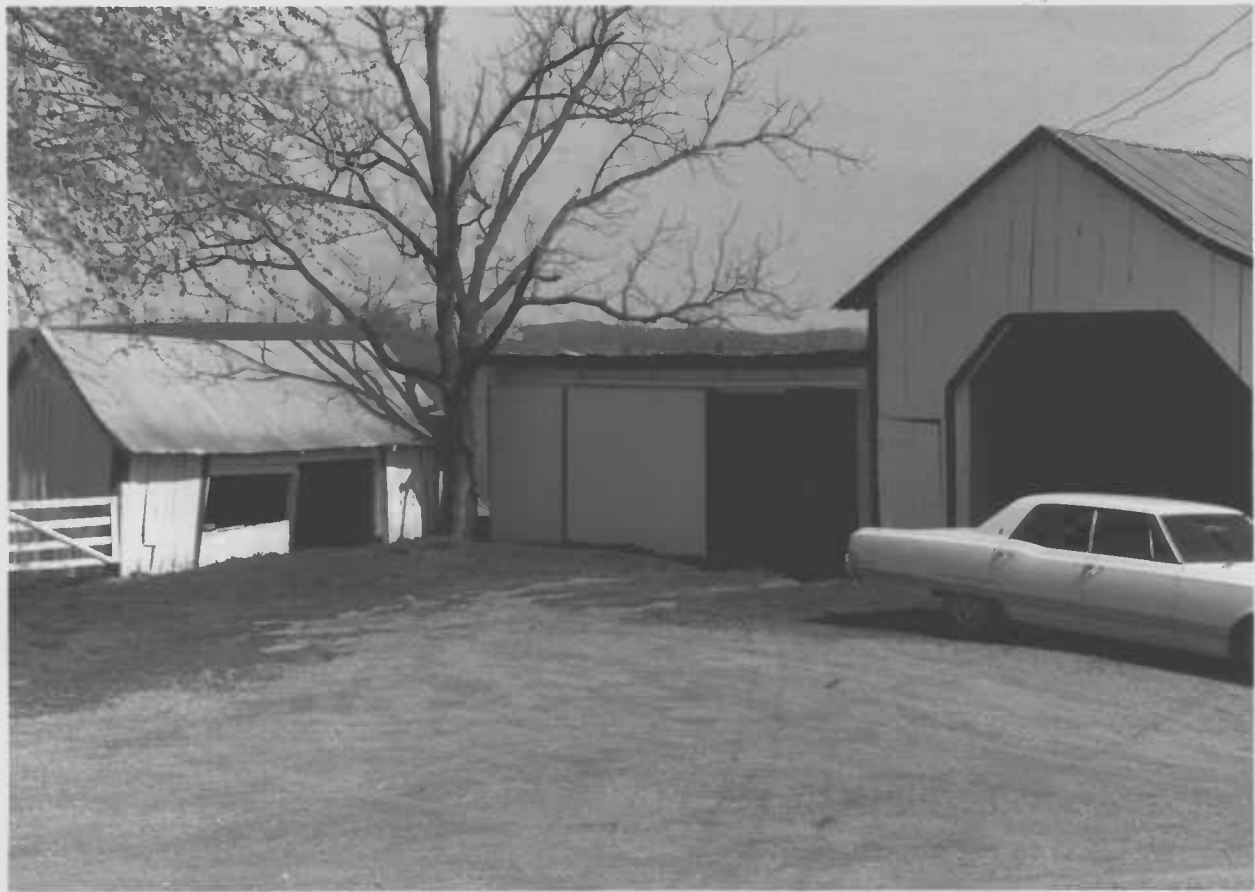
3/5

Blacksmith shop: The 1 story frame blacksmith shop is located about 25 yards northeast from the domestic outbuildings. It has vertical flush board siding and a corrugated metal gable roof. It contains an anvil and a considerable amount of original materials and equipment, although not in use. It is

probably mid 19th century in date. Many of the buildings in the complex have hand-made hardware made in the shop.

Tractor shed: The shed-roofed concrete block shed with sliding doors is located at right angle to the blacksmith shop. The doors appear to date from the last quarter of the 19th century, while the shed is apparently early 20th century.

Corn crib: Adjoining the tractor shed on the southeast is a frame, pull-through double corn crib. With vertical siding and a standing seam roof, it is also dated in the last quarter of the 19th century.

Blacksmith shop, tractor shed, corn crib (l to r)

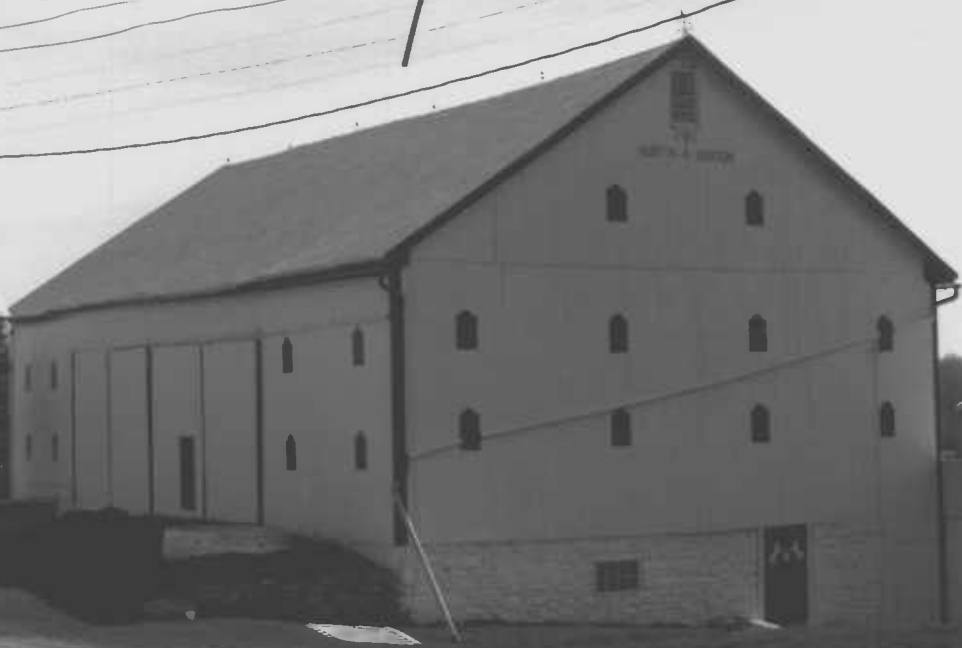
4/5

Bank barn: The frame bank barn was built in 1903 to replace an earlier bank barn which stood north of the house. The foundation is stone and the vertical siding has painted "windows". In the gable is a 6/6 window and the owner's name and the year, 1961, that the farm was purchased from his father. The standing seam metal roof covers the original slate roof. Inside the barn are two cow feeding aisles and a separate horse stall section. On the southeast side is a fiberglass roofed loafing shed. An equipment and wagon shed with a corn crib is on the north end of the barn. A cistern is located near the southwest corner and a concrete silo near the northwest corner.

Bank barn, view from west

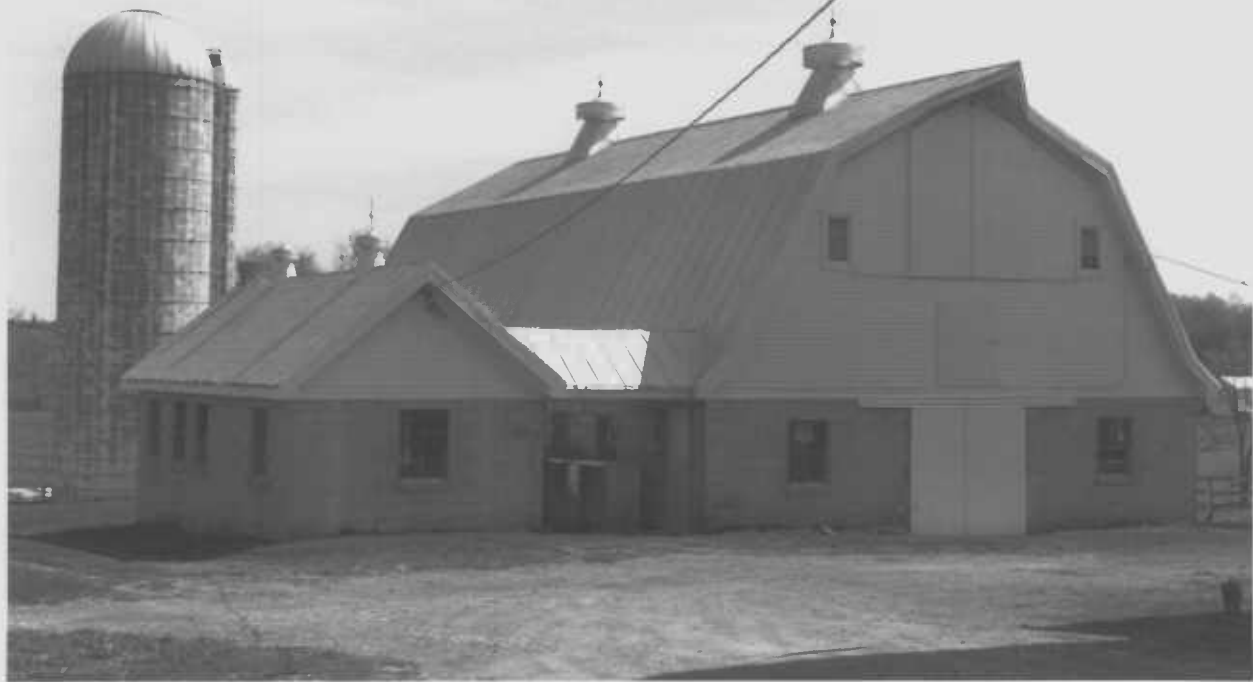
5/5

Dairy barn: A 1951 concrete block dairy barn with a standing seam metal gambrel roof, an adjoining can storage building, and a concrete silo are located northeast of the bank barn.

Dairy barn
